# TGUP Project Details

## One or two new classrooms

### Las Flores Public Rural School

#### **PROJECT NAME: Las Flores Classrooms**

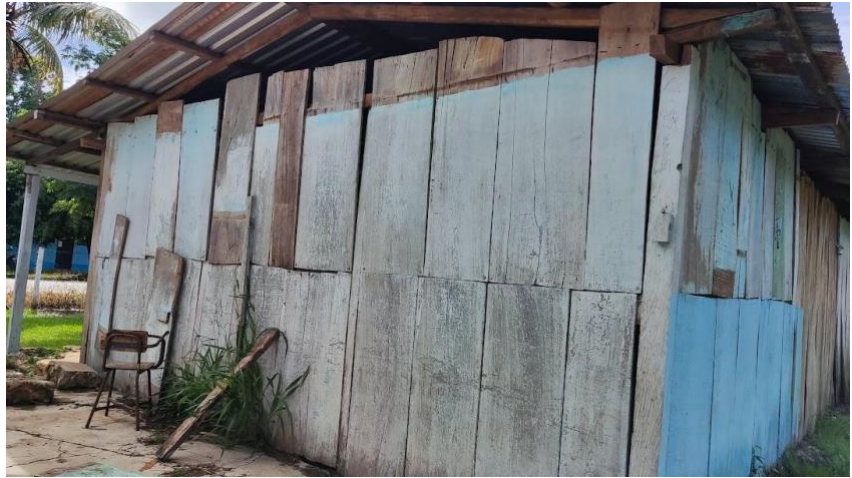
This project will build two classrooms measuring 26x20 feet each, for a total of 20x52 feet of construction. The foundation and the building will be made of cinder blocks with rebar-

reinforced concrete columns and beams. The floor of the main building and the sidewalk will be made of concrete reinforced with steel mesh. This will be finished with a thin and smooth cover made of cement and fine sand to ensure easy and thorough cleaning. The roof will be a steel structure, with 4"x2"x20' steel beams and u-shaped 4"x2"x20' purlins. This structure will be roofed with galvanized metal sheets.

The project includes the installation of electrical wiring and lights. Each classroom will have two doors that will be locally made with metal frame and steel sheets. The windows will be protected with metal bars. In front of the building will be a roofed sidewalk of 52x9 feet. The classroom will look similar to the one in the photo below.
